INSPECTION REPORT

Alaska Department of Environmental Conservation

PHOTO ADDENDUM – KENSINGTON MINE – MAY 5, 2011

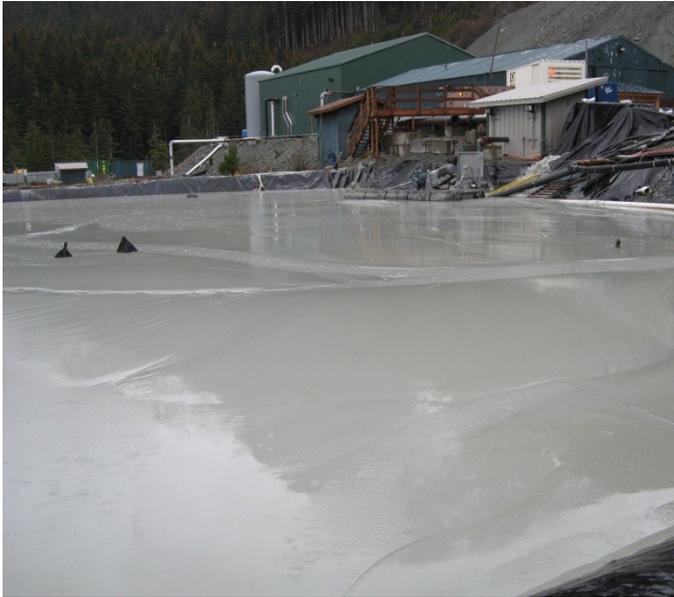
Pond 1 – a new sediment dredge (Dino Six) was being commissioned by Emerald Environmental (Photo 1). This has an 8' 6" wide auger that cuts into the sediment and pumps it up to a sediment bag (Photo 2). Sediments are trapped in the bag and water flows out of the fabric (420 µm. mesh openings size) (Photo 3). To aid capture of the very fine "glacial flour" size sediment SpinPro 75 anionic floc is to be used (Photos 4 & 5). A larger bag, or more bags, will be installed in the

PHOTO 1. POND 1 SEDIMENT DREDGE

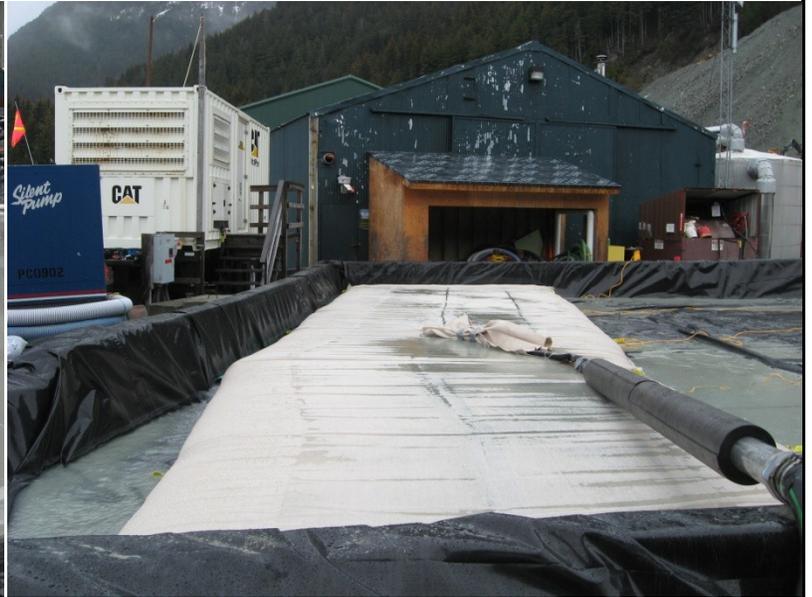
PHOTO 2. SEDIMENT BAG

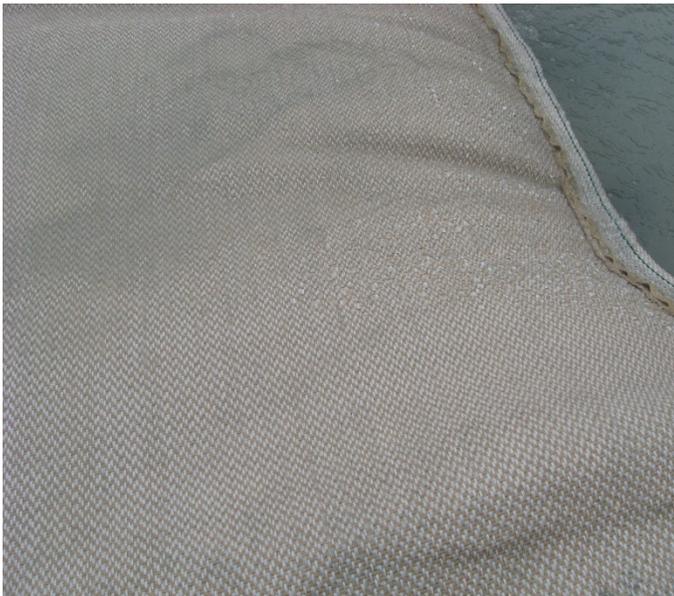
PHOTO 3. SEDIMENT BAG 420 μM OPENING

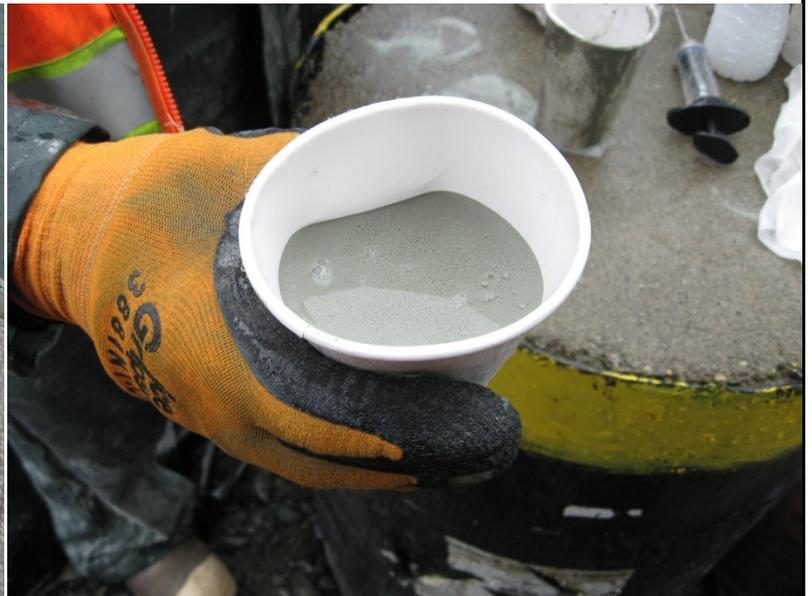
PHOTO 4. ANIONIC FLOC TEST FOR SEDIMENT CAPTURE

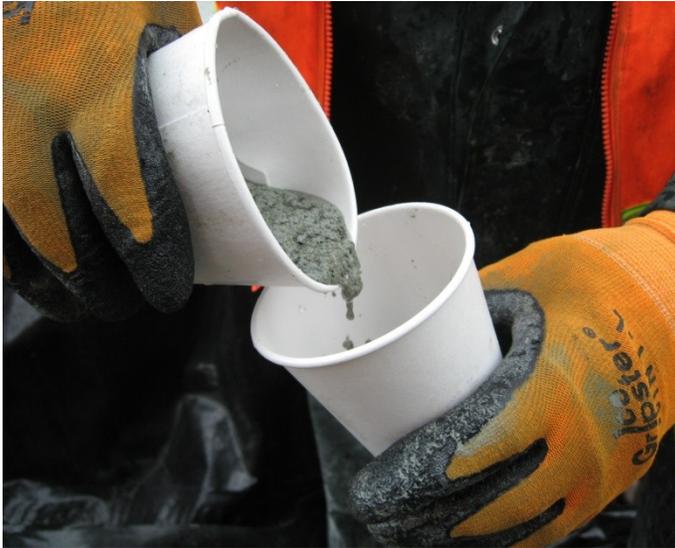
Photo 5. Floc formed by sediment

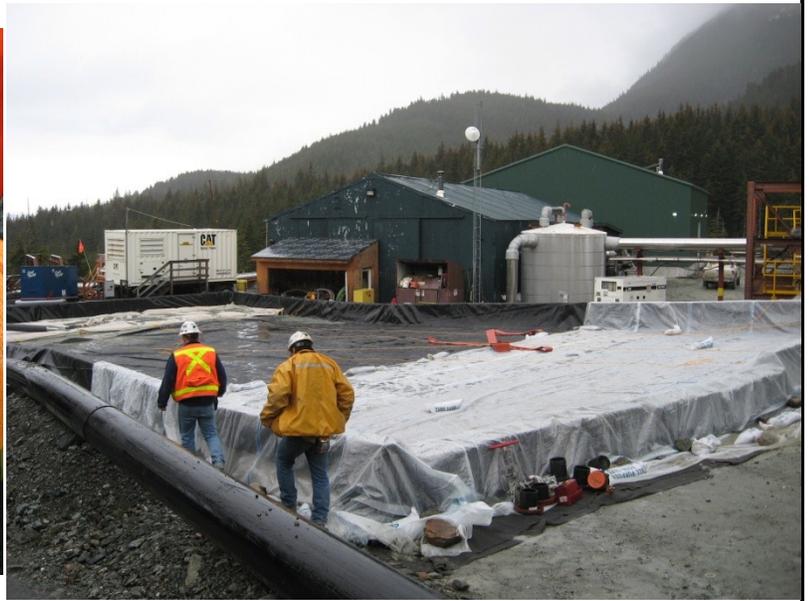
containment (Photo 6) later. The bags will fill during the day, then be left to gravity settle at night, then filling will re-commence the next day. This will continue for a few days until the bag is full. It is thought the pond will be cleaned of sediment within approximately 1 month. Once dewatered to around 25% moisture (no free moisture once down to 15%), it will be taken underground or incorporated into the production rock pile for final disposal.

Photo 6. Sediment bag containment area

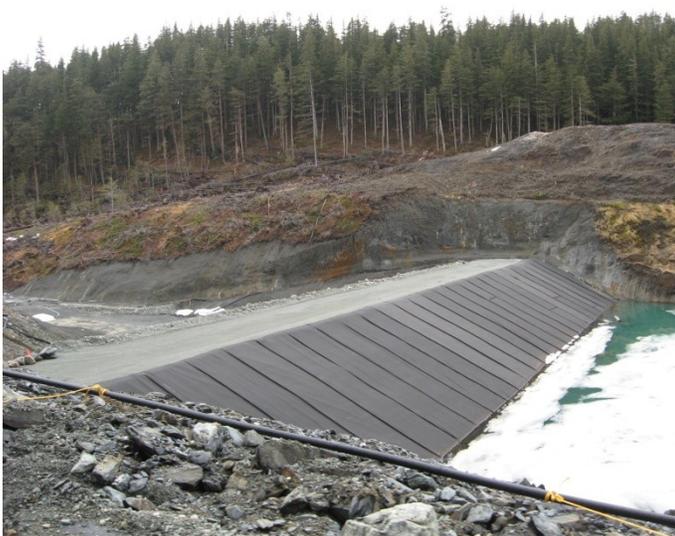
Some ice was still on the pond. Logs will be removed from in front of the dam (Photo7) when the ice has melted and a floating log barrier installed to protect the membrane on the dam face. The ARD plant has been operating at about 7 to 15 gpm. The TTF treatment plant has been operating at just under 1100 gpm.

Photo 7. Dam at the Tailings Treatment Facility

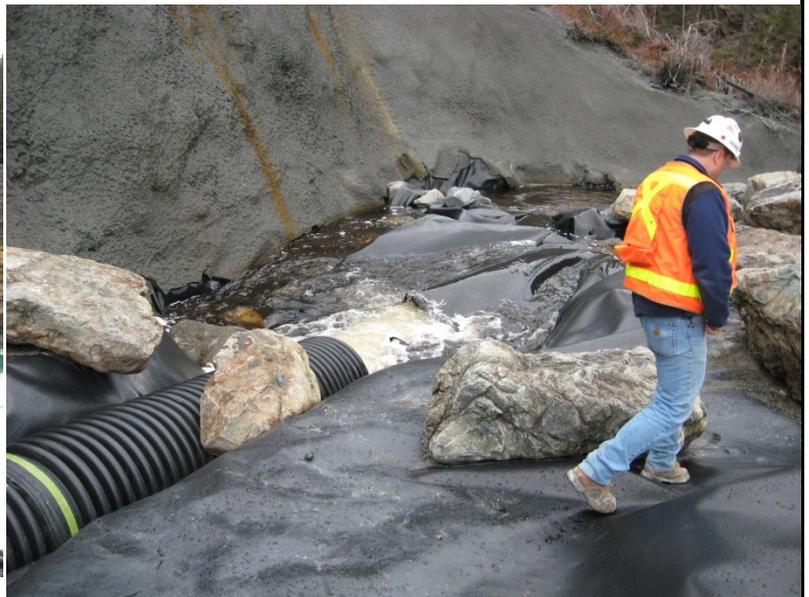
The polyethylene underlayment at the outlet of the diversion pipe (Photo 8) was ripped. This has occurred before, indicating this may be a regular reoccurrence. The polyethylene is to ensure fish do not impact rocks as they a leave the diversion pipe. The requirement for the polyethylene will be discussed with ADF&G.

Photo 8. Damaged polyethylene sheet at the TTF diversion pipe outfall.

1. BMP's required to prevent storm water filling secondary containment at the transformer and aerosol puncture drum.
2. BMP's required to contain sediment from the road area adjacent to Pond 1 at the Comet treatment plant.
3. Modifications are to be made with the polyethylene sheet at the TTF diversion pipe outfall. ADF&G discussing this with Coeur.
